66 Louis Prang Street, Boston, MA

Owner: Wentworth Institute of Technology, Boston, MA

Timeline: August - December 2015

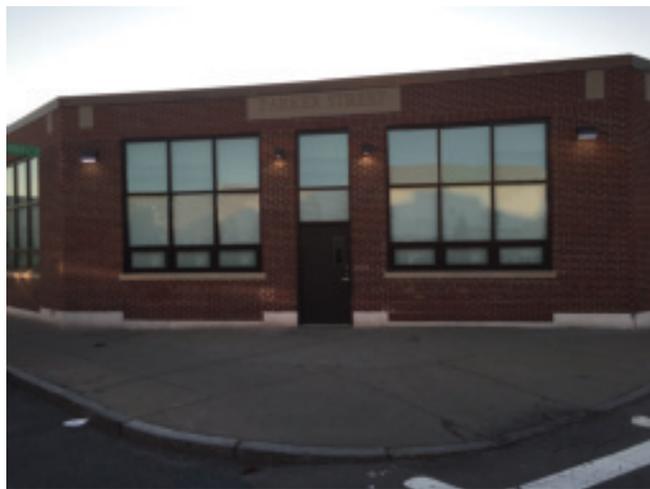
Abbot's evaluated the building and identified the following major deficiencies:

- The brick masonry was extremely dirty
- The window sills were deteriorated and in some cases non-existent
- Brick above the windows to the roof had deflected and was no longer in plane with walls
- The windows were non-existent and filled with concrete block

Based upon this comprehensive evaluation, Abbot performed the following sequence of repairs:

- All brick was power washed with a restoration cleaner to remove existing dirt, and paint was removed from bottom of perimeter of building to provide for a natural brick appearance
- All brick joints were repointed
- All of the bricks were removed from the top of the windows to the roof line, and entirely rebuilt using new matching brick
- The concrete blocks were removed from all windows
- New pre-cast concrete window sills were fabricated and installed to replace deteriorated and non-existent sills,
- New key stones were installed in the parapet corners to decorate the walls
- New energy efficient windows with security screens were installed
- The foundation and balance of the existing poured concrete was coated with an elastomeric material to improve the building's appearance
- Finally, a new precast front sign was fabricated to match the original sign
