## **33 Chestnut Street, Boston, MA**

Owner: 33 Chestnut Street Condominium Association

Timeline: Spring 2016

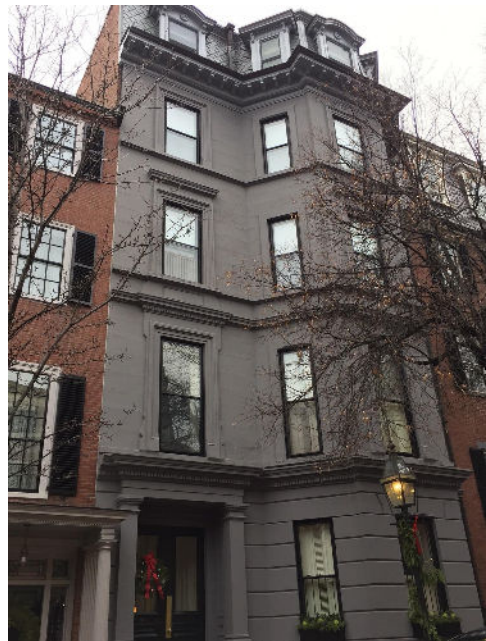
As is often the case due to Abbot's strong client relationship and quality workmanship, the Condominium Association proactively contacted Abbot in the Fall 2015 to reevaluate the condition of the front of building. Abbot determined that the previous restoration performed in 2003 was still in excellent condition. However, the new investigation uncovered deterioration on the mansard windows and dormers that were not part of Abbot's original restoration work.

Based on this new evaluation, Abbot was contracted to perform repairs in the spring of 2016. The repairs consisted of wood dormer restoration, including removing all of the trim around the mansard windows and some of the wood framing, and replacing the deteriorated wood with new wood. Abbot also removed the dormer roofs and replaced them with new roofing.

Below the mansard, Abbot hammer tested the brownstone and removed any defective regions. Abbot then repaired these areas with a special brownstone colored repair material as directed by the Beacon Hill Architectural Commission. The Commission's rationale for requiring special colored repair material was the understanding that if the coating were ever removed from the façade in the future, the new repairs would match the original brownstone to create a natural appearance. Finally, Abbot recoated the brownstone façade with the same approved color coating to create a uniform appearance, and caulked and painted all of the windows and the front door.
