294 Washington Street/10 Milk Street, Boston, MA

Owner: 294 Washington Street LLC, Boston, MA

Architect: CBI Consulting Inc., Boston, MA

One of the Largest Repair and Restoration Projects in Abbot's 80+ Year History

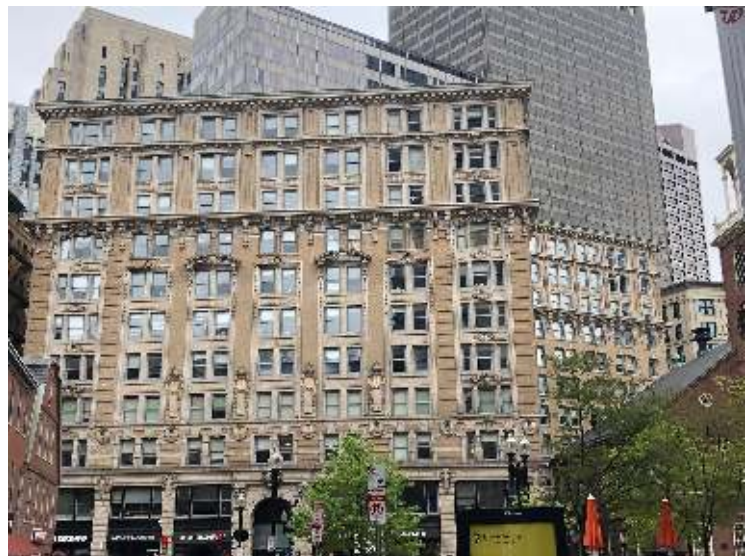
Figure 1. 294 Washington Street, Boston MA

The first phase of the project took place at the back left corner of the Spring Lane side of 294 Washington Street. This phase consisted of demolition of the brick corner from the roof to the ground to expose the steel column. Following demolition, Abbot repaired the deteriorated steel in the

column and rebricked the corner to match the existing brick. Abbot also conducted other repairs on the back wall and the interior light well.

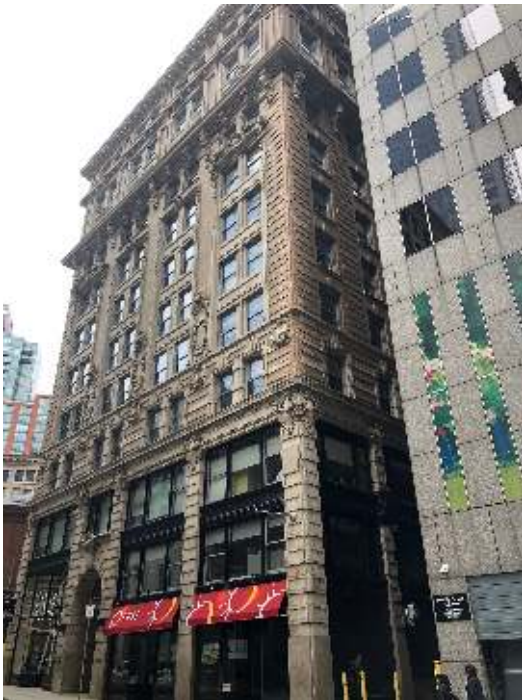
Figure 2. 10 Milk Street, Boston, MA

Phase 2 of the project focused on the Milk Street building face and courtyard. This phase began with the removal of the ornamental 4-foot terra cotta shelf on the 9th floor, and replacing it with GFRP (fiberglass) replicated to match the original appearance.

Importantly, it was determined through inspection that the terra cotta had deteriorated and was debonding from the building.

Based on the engineer's recommendation, it was decided to remove the entire terra cotta shelf to expose the structural steel, and then repair the structural steel, adding new steel framing and a pressure treated wood top. The finished appearance of the shelf was then replicated with GFRP (fiberglass) panels to match the original shelf.
