600 Parker Street Street, Boston, MA

Owner: Wentworth Institute of Technology, Boston, MA

Timeline: August - December 2015

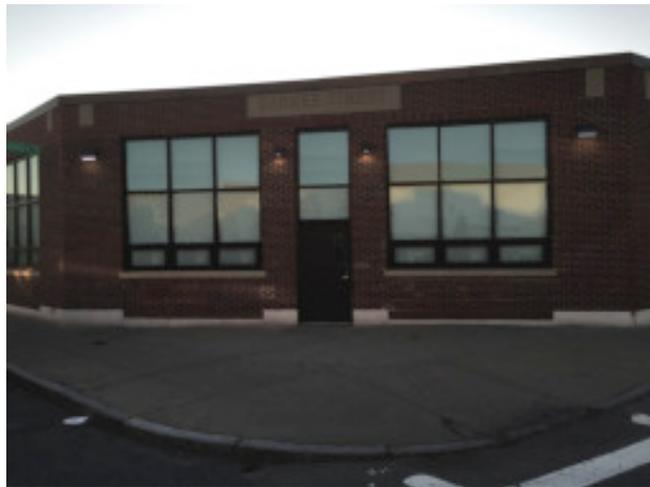
Abbot's evaluated the building and identified the following major deficiencies:

- The brick masonry was extremely dirty
- The window sills were deteriorated and in some cases non-existent
- Brick above the windows to the roof had deflected and was no longer in plane with walls
- The windows were non-existent and filled with concrete block

Based upon this comprehensive evaluation, Abbot performed the following sequence of repairs:

- All brick was power washed with a restoration cleaner to remove existing dirt, and paint was removed from bottom of perimeter of building to provide for a natural brick appearance
- All brick joints were repointed
- All of the bricks were removed from the top of the windows to the roof line, and entirely rebuilt using new matching brick
- The concrete blocks were removed from all windows
- New pre-cast concrete window sills were fabricated and installed to replace deteriorated and non-existent sills,
- New key stones were installed in the parapet corners to decorate the walls
- New energy efficient windows with security screens were installed
- The foundation and base of the existing poured concrete was coated with an elastomeric material to improve the building's appearance
- Finally, a new precast front sign was fabricated to match the original sign
