## 35 Wareham Street, Boston, MA

## Rebuilding of Interior and Exterior Brick Walls at Historic South End Commercial Building

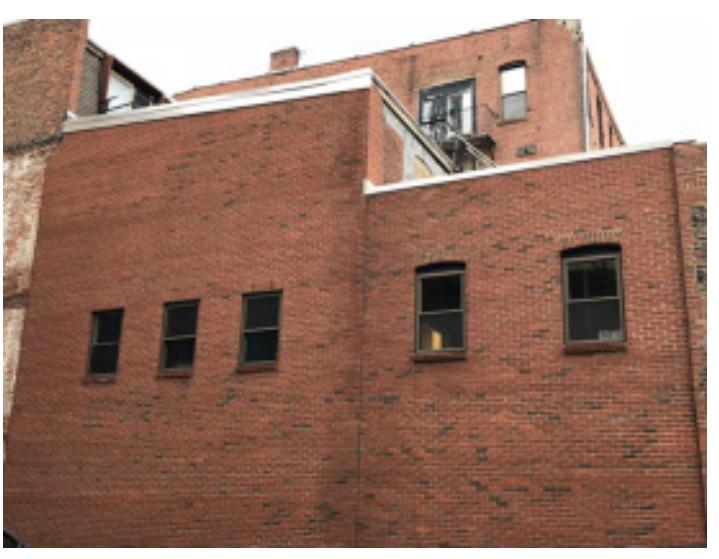
Figure 1. 35 Wareham Street (rear), Boston, MA

Recently, the building owner observed that the building's exterior brick wall was pulling way from the interior brick wall. Abbot investigated the problem and determined that the connection points between the walls had deteriorated to the extent that a void was created between the walls.

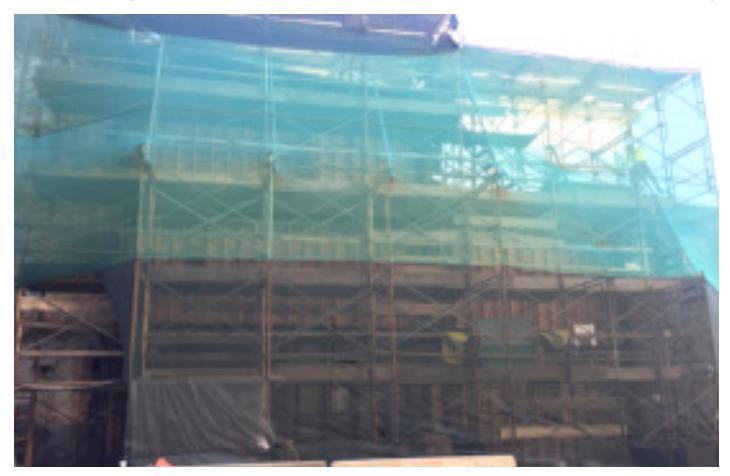
Figure 2. The scaffolding is braced by Jersey barricades enclosed with netting exposing completed demolition of brick walls and interior wood shoring walls.

the wall, Abbot installed a series of Jersey barricades to brace the scaffolding support. The scaffolding was then completely enclosed to assure that it would be water tight to protect it from the elements.

interior wall using 8-inch CMU blocks filled with cement and steel reinforcement. Abbot then mechanically anchored the new exterior brick wall to the CMU wall using bricks resourced to match the original bricks. Four window openings were created during the masonry project with wood framing and installation of new bronze double hung replacement windows in the same locations as the original windows. To complete the construction, Abbot removed the temporary wood beam shoring on all floors.
