1871-1875 Commonwealth Avenue, Boston, MA

Owner: Commonwealth Place Condominium Association, Brighton, MA

Consultant: Structures Engineering Inc., Marshfield, MA

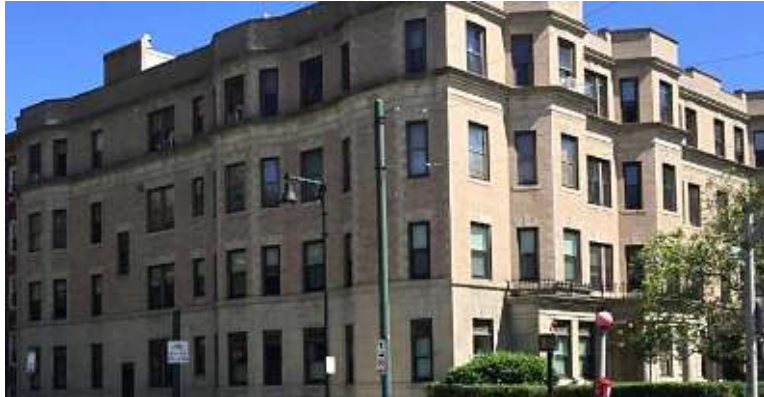
Abbot completed the initial phases of the project back in 2012 focusing on the Chestnut Hill Avenue side of the building where repointing, stone repair, brick replacement, and caulking of the windows were performed, along with major structural repairs to several damaged stucco porches in the rear of the building.
