Abbot's experience in historical masonry well suited to restoring brick Victorian homes

Abbot Building Restoration

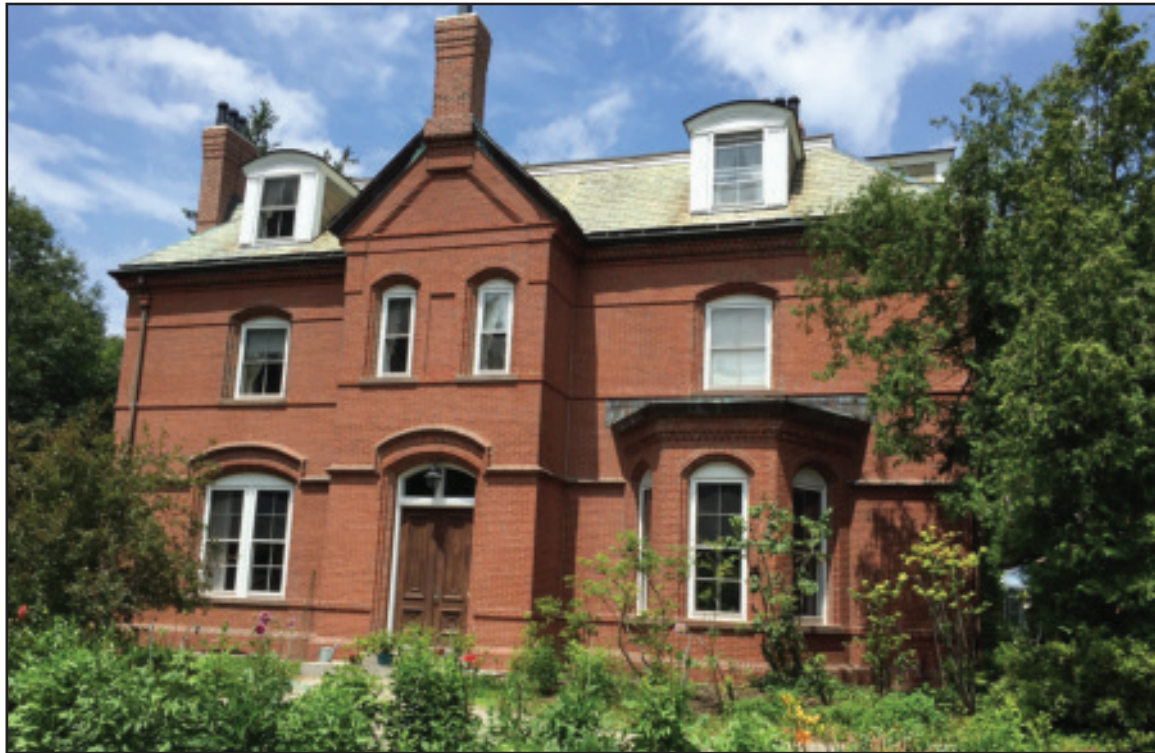
Victorian house in Milton, Mass: Abbot performed brick restoration on the north (left) side and west (front) sides of the house in separate phases. As evidenced by the photograph, the appearance of the brickwork is identical demonstrating the consistency and quality of the workmanship throughout the both phases.

The scope of the entire project consisted of 100% repointing and replacement of the deteriorated brownstone with precast concrete to match the color, shape, and size of the original brownstone. The owner elected to phase the work over a four-year span, completing phases 1 and 2 over 2014-2015, with two additional phases to be completed in 2016 and 2017.

In phases 1 and 2, Abbot cut and pointed all of the brick, replaced some of the brownstone window sills and headers, and replaced the stones under some of the windows on the north (left) and west (front) sides of the house. Significantly,

Abbot was able to formulate the mortar to match the original color used on the building.

Significant to both projects, Abbot resourced the mortar to match the existing colors, and carefully removed the old mortar between the narrow joints to avoid damaging the brick facades. To assure that the brick would not be damaged during the restoration, Abbot employed an advanced technology vibrating knife with a diamond tip to carefully cut out the mortar.

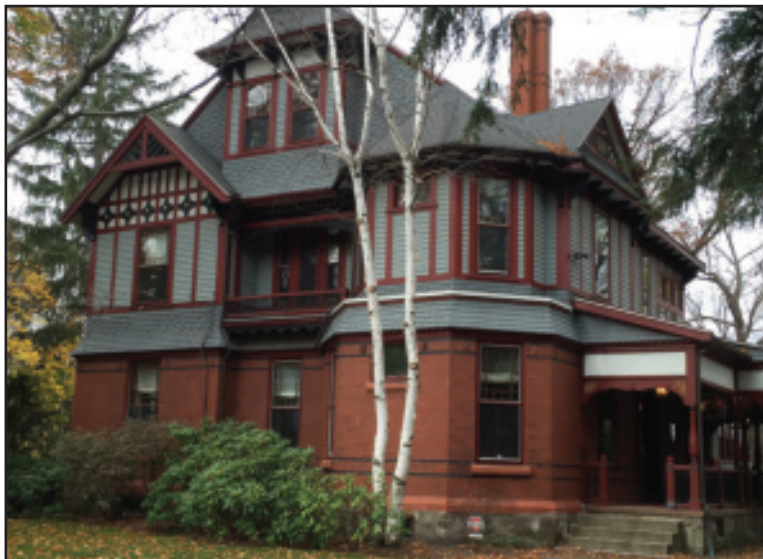
Victorian house in West Newton, Mass.: Abbot was contracted to cut and point all of the brick, seal around the perimeter of the windows, and perform masonry work on the foundation.

Feeling that the house needed some brick masonry maintenance work, the owners researched the Internet, found Abbot's new web site (www.abbotbuilding.com), and were impressed with Abbot's experience with historic masonry work. The owners contacted Abbot in the fall of 2015 to provide an evaluation and a cost estimate for the project. Abbot was then contracted to cut and point all of the brick, seal around the perimeter of the windows, and also perform masonry work on the foundation.
