## **Complex Masonry Repair and Restoration Project for Boston Museum of Science**

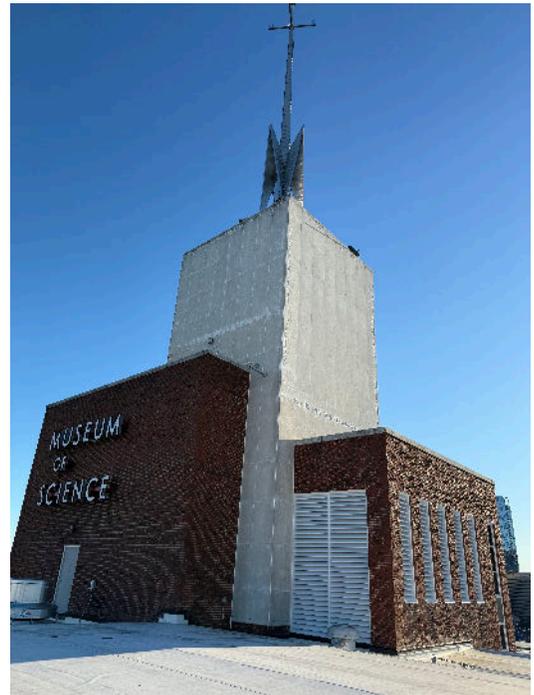
The first phase of the project focused on deterioration issues on the white marble tower situated over the main entrance to the building. Of immediate concern was the failure of the caulking within the joints between the marble panels. After initial inspection and considering the age of the existing caulking, Abbot suspected the presence of asbestos, had a sample tested, and confirmed its presence. This required hiring Alpine Environmental (Chelmsford, MA) to perform an abatement to remove the hazardous material.

Before the repairs could begin, access to the work area needed to be established. This presented a unique challenge as the only way to reach the area was by erecting pipe staging from the sixth-floor roof and several adjacent roofs surrounding the tower, which itself consisted of multiple levels. Typical scaffolding ties could not be used because they would require anchoring into the marble façade. To secure access, the staging contractor (Lanco Scaffolding, Inc., Boston, MA), built a fully wrapped scaffold system around all four

sides of the tower and tied it together at the top along with the use of pressure-only ties against the marble without penetrating it. Transporting all of the staging materials to the roof added another layer of complexity, as all materials had to be moved through the building, up a freight elevator, and then up a stairwell.

Once the scaffolding was in place and the abatement was complete, Abbot was able to fully recaulk all of the joints, scrape and paint several large louvers, and complete additional repairs around the windows from a third-floor roof.
