Coming full circle - A recurring theme

Abbot Building
Restoration

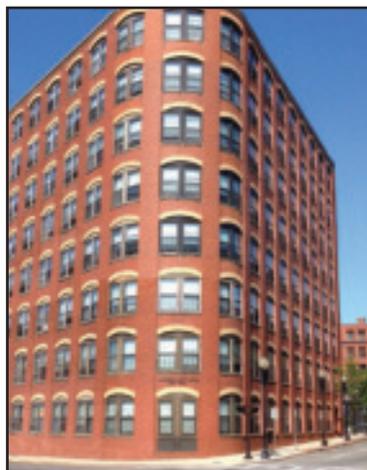
Harbor Loft Apartments - Lowell, MA

A common theme in Abbot's 76-year history has been performing work several times on the same building for different owners. Take Harbor Loft Apartments as an example. Harbor Loft is an elegant 8-story brick high-rise building located at the corner of Washington and Broad Sts. in downtown Lynn. When the building was converted to public housing back in the 1960s, Abbot became involved with some minor repairs at that time. Coincidentally, Abbot has come full circle some 50 years later, and was recently contracted by the current building owner to perform maintenance on Washington St. elevation that was experiencing severe water penetration around the windows and masonry.

The contract called for Abbot to cut out and repoint the masonry on the top five floors where the most severe water damage had occurred. Also, as a previous

contractor has resealed the windows improperly, Abbot removed the defective sealant around multiple joints on each window -- metal to masonry, metal to metal, and metal to glass -- and removed all of the remaining residue. Abbot then resealed the affected locations with a high-grade polyurethane sealant to match the original color around the exterior of the windows. Finally Abbot applied a clear water repellent to help protect the masonry surfaces.

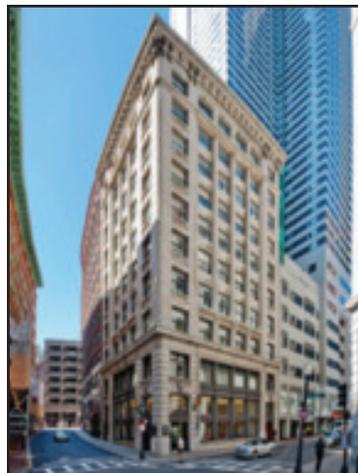
85 Devonshire Street, Boston, MA

On the 5-story north elevation, the brick wall that corresponded with the elevator shaft was experiencing severe leakage likely attributed to the multiple dislodged bricks and deteriorated windows. The contract called for Abbot to repair the dislodged bricks, install new brick in place of all of the windows, repoint the entire brick wall and seal the wall with two coats of an elastomeric protective coating. The project was complicated by the need for Abbot to move its equipment over an abutter's roof by crane, erect the equipment, and then remove the equipment by crane after the job was completed.

Phase 1 of the restoration project involved the 12-story south, west, and east elevations where Abbot repaired various perimeter wall defects as indicated in a report by the engineering firm (D.M. Berg Consultants) contracted by the building owner. The repairs consisted of pinning defective stones and sealing numerous cracks to bring the building in compliance with the city of Boston Façade Ordinance Code.
