Leventhal-Sidman Jewish Community Center (JCC)

Chimney Repair

Drone Technology Used to Identify Areas of Water Penetration

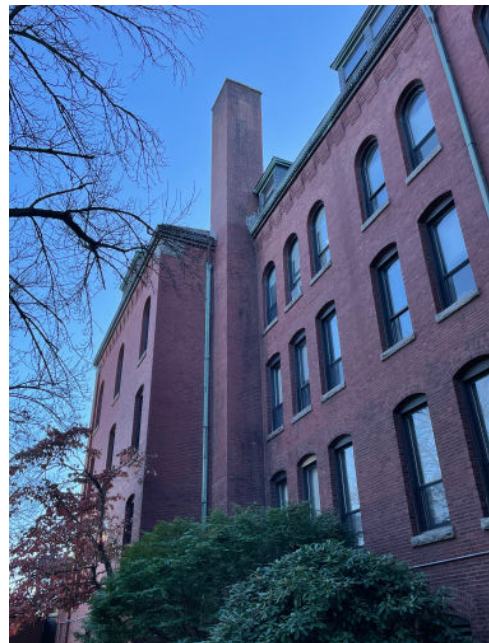
As the building had been taking on water for some time, the JCC management team initially hired a roofing contractor to inspect the roof and patch areas where necessary. However, the leak persisted following the roof repair leading management to focus on the chimney. Their next step was to hire an engineering company that utilized advanced drone technology to provide a close up view of all sides of the chimney. This precise inspection identified significant damage to the brick, failed pointing, severe cracks in the cap, and a lack of sealant/mortar under the chimney liner flange.

Based on a strong working relationship over the years, the JCC management team contracted Abbot to provide essential repairs to the chimney. After erecting pipe staging to access the chimney from the roofline to the top of the chimney, Abbot utilized its masonry experience and expertise to cut and point the entire chimney, replace all of the cracked bricks, patch the chimney cap cracks, and sealed the gap between the metal flange and chimney cap. Abbot then applied two coats of clear sealer onto the brick to provide a secure waterproof barrier. After Abbot's work was completed, the roofers returned to replace any damaged slate and to repair visible roofing defects.
