First Haitian Baptist Church of Boston Roxbury MA

Architect: Wessling Architects, Braintree, MA

Timeline: Phase 1: September 2023; Phase 2 Ongoing

Rear Wall Repair

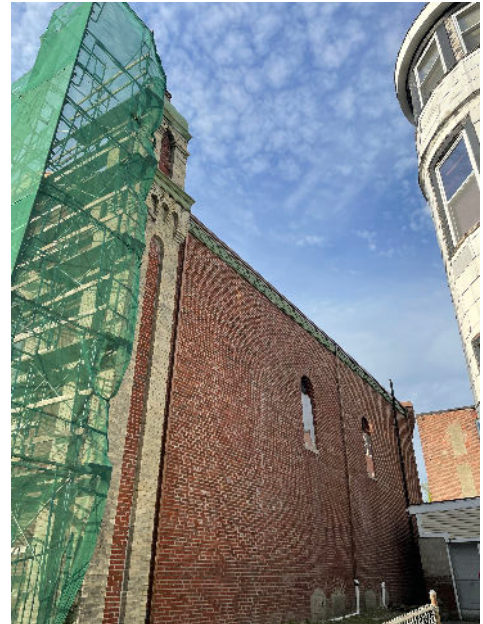
The first phase of the project focused on the rear of the building where it was apparent that large areas of the brick had debonded and were pulling away from the backup wall. So that Abbot could evaluate the extent of the debonding, Abbot erected pipe staging to access the entire wall allowing a series of test holes to be created in areas specified by the architect. Based on this evaluation, it was determined that certain areas needed to be completely demolished and rebuilt with new brick to match the color and texture of the existing brick. The back-up wall also required repair as needed.

Abbot filled and parged any open holes while parts of the outer wall were being rebuilt. Abbot then cut and pointed the remainder of the wall. To complete the repairs, the roofing contractor (SRC Roofing, Quincy, MA) installed a new gutter along the entire length of the wall as well as new downspouts.
