Abbot's Experience in Historical Masonry Restoration Well Suited to Restoring Brick Victorian Homes

Boston, MA, April 1, 2016 -- The Victorian era roughly corresponds to the time when Queen Victoria ruled Britain (1837-1901) during which period the styles known as Victorian were used in construction. During this time, industrialization brought many innovations in architecture.

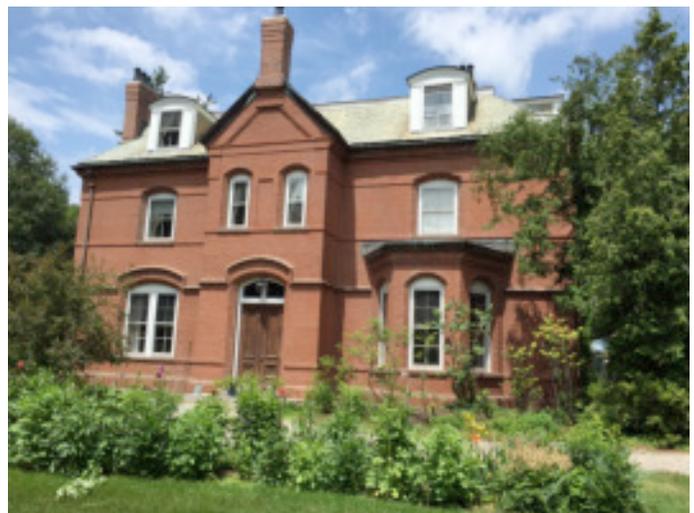
Abbot performed brick restoration on the north (left) side and west (front) sides of the house in separate phases. As evidenced by the photograph, the appearance of the brickwork is identical demonstrating the consistency and quality of the workmanship throughout the both phases.

The scope of the entire project consisted of 100% repointing and replacement of the deteriorated brownstone with precast concrete to match the color, shape, and size of the original brownstone. The owner elected to phase the work over a four-year span, completing phases 1 and 2 over 2014-2015, with two additional phases to be completed in 2016 and 2017.

In phases 1 and 2, Abbot cut and pointed all of the brick, replaced some of the brownstone window sills and headers, and replaced the stones under some of the windows on the north (left) and west (front) sides of the house. Significantly, Abbot was able to formulate the mortar to match the original color used on the building.

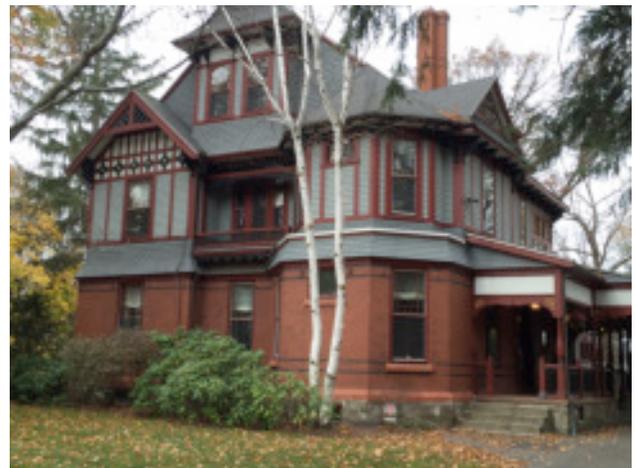
The second Victorian house, built in 1880, is located in West Newton, MA. Constructed of masonry and wood, this house features 7 bedrooms and 5 baths, and has 6053 square feet of living area.

Abbot was contracted to cut and point all of the brick, seal around the perimeter of the windows, and perform masonry work on the foundation.

Significant to both projects, Abbot resourced the mortar to match the existing colors, and carefully removed the old mortar between the narrow joints to avoid damaging the brick facades. To assure that the brick would not be damaged during the restoration, Abbot employed an advanced technology vibrating knife with a diamond tip to carefully cut out the mortar.
