Bethany Hill Framingham, MA

Restoration of Three-Story Brick and Stone Building

Owner: Sisters of Saint Joseph of Boston, Brighton, MA

Architect: Gorman Richardson Lewis Architects, Hopkinton, MA

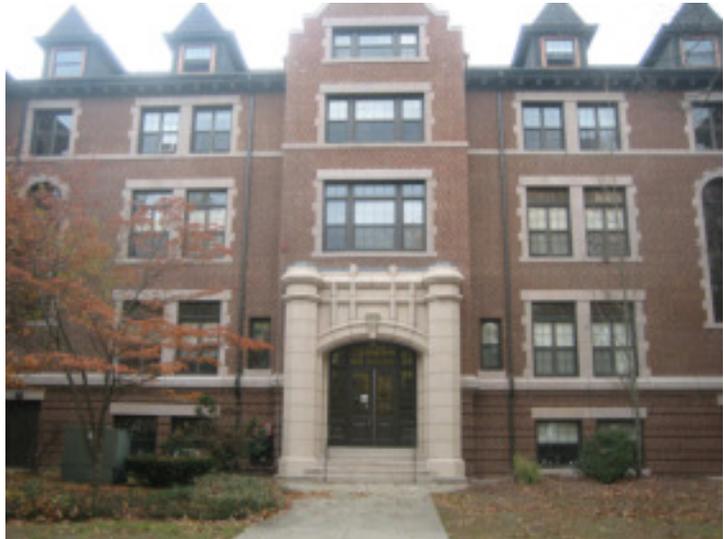
Bethany Hill is a 1920's-era three-story brick and stone building located on a 100-acre rustic setting in Framingham, MA. The building was designed and developed by the Sisters of Saint Joseph of Boston, MA in partnership with the South Middlesex Opportunity Council (SMOC) and other program sponsors in the Boston/MetroWest area. The property served for many years as a novitiate building until 1994, when it was converted to affordable community housing.

In the Spring of 2011, Abbot was contracted by the owner with the assistance of an architectural consultant (Gorman Richardson Lewis, Hopkinton, MA) to restore a major portion of the building that had deteriorated over the years. The restoration involved the brick façade, pre-cast stone above the windows, steel behind the stone, pre-cast stone portico at the front entrance, and slate roof. A key consideration throughout the project was to preserve the original appearance of the building in all facets of the restoration.

At the peak of the north elevation, the outer width of brick had to be completely removed, and then replaced and waterproofed due to water damage. These bricks had an unusual deep red color and tapestry texture that required significant research to match. Abbot was able to source new bricks that matched the color and texture of the existing bricks to maintain the original appearance. In addition, the remaining brick joints were cut and repointed throughout the entire facade.

The deteriorated pre-cast stone headers, sills, and bands above the windows were either removed and reinstalled or replaced. Although the surfaces of the stones were a unique white color with black flecks, Abbot was able to match their appearance so precisely that it was difficult to distinguish the new stones from the original. In addition, the steel behind the stones was removed and replaced where needed with galvanized steel.
