## Abbot restores town of Wellesley Hegarty water pump station facade

Hegarty Pump Station - Wellesley, MA

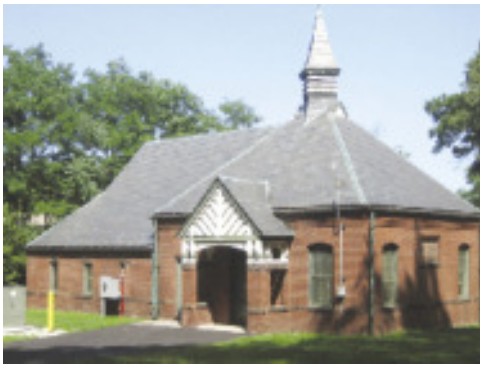
Abbot Building Restoration recently completed a masonry restoration project at the Hegarty Pump Station, a one-story brick building operated by the town of Wellesley water department, whose façade was in need of significant repair.

Abbot was contacted by the town to evaluate the brick and mortar deterioration, and provide remedial action. Abbot's solution was to first power wash the entire building to remove the atmospheric dirt and moss, and then repoint the brick where needed. Abbot then rebuilt the badly deteriorated brick on the column to the left of the main entrance way. To complete the project, Abbot applied a water repellent industrial coating to the entire façade to provide a durable weather resistant protective barrier.
