Leventhal-Sidman Jewish Community Center 333 Nahanton Street, Newton, MA

Restoration of Clock Tower and Grand Staircase

Owner: Combined Jewish Philanthropies, Boston, MA

Design: D.M. Berg Consultants, Needham, MA

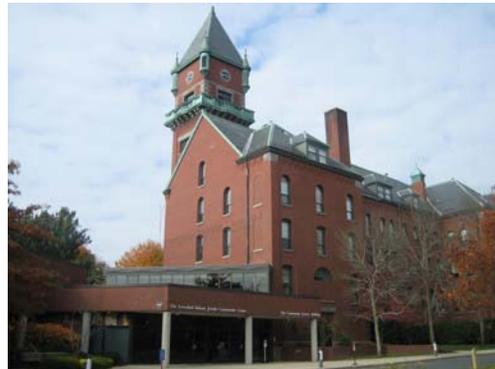
The Leventhal-Sidman Jewish Community Center was originally a 4-story Victorian structure and gymnasium with a 7-story square clock tower at the right front wing. Constructed in 1886, the building was used as the Working Boys Home Industrial School run by the Archdiocese of Boston, and then later as a Novitiate for the Xavarian Brothers Clergy until it was purchased by the Combined Jewish Philanthropies of Greater Boston (CJP) in 1979, and renovated for use as an office and community recreational center in the early 1980s. The renovation included a 4-story addition that linked the existing structures by a skylighted walkway.

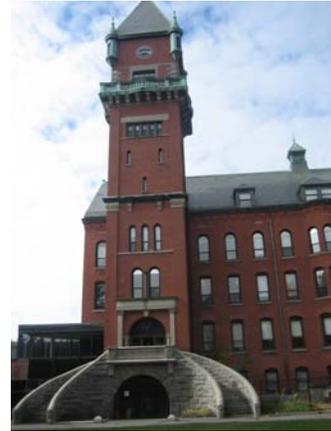
Due to budgetary constraints by the CJP, minimal maintenance and repair work was done to the building at the time of renovation. In 2004, an architectural firm (D.M. Berg Consultants, Needham, MA) was contracted to evaluate the structural integrity of the clock tower due to concerns by the CJP. During the evaluation, vertical cracks were discovered in the brick corners and the passage doors leading to the perimeter copper-clad balcony were severely deteriorated. Further, the overall condition of the masonry joints was poor.

Abbot was contracted to completely rebuild one of the brick corners, replace deteriorated brick on the other corners, and repoint all four sides of the tower. Also as part of the project, Abbot replaced all four sets of passage doors with heavy-duty metal and glass doors that were engineered to withstand severe weather conditions. In addition, Abbot replaced the copper panels on the turrets and installed screening to protect the eaves from birds and other predators that could create an environmental hazard.

During the construction process, the wood floor of the balcony was found to be deteriorating badly. Abbot removed the old floor, reframed the balcony, installed a new wood floor, covered the floor with a waterproof EPDM roofing material to protect it from the elements, and repaired the copper perimeter of the balcony to restore its original appearance.

As an added touch, Abbot restored the clock face and replaced the Roman numerals with Hebrew letters at the owner's request.

As the final phase of the project, Abbot power washed the horseshoe-shaped grand staircase located at the bottom of the tower, and completely repointed the stone joints.
